Backa röd, Gothenburg, Sweden

Project summary

Energy concept: To achieve a substantial reduction of the energy losses

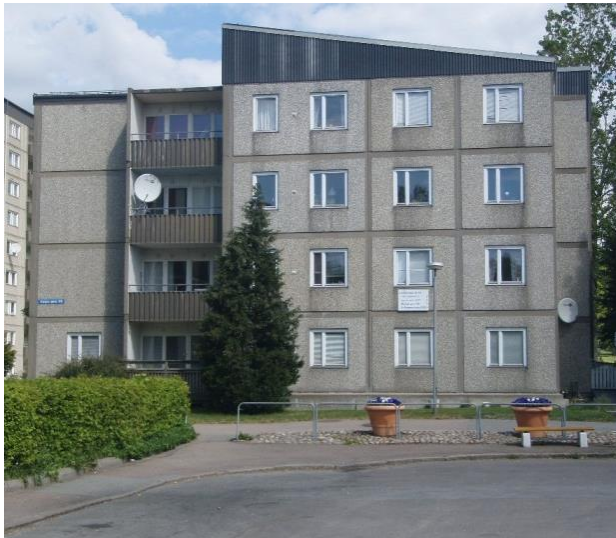
Before renovation.

The buildings are typical for the seventies with a prefabricated concrete structure of sandwich facades panels. The facades were damaged by carbonation and were in need of renovation.

The building was leaky, through the façade and between the apartments. Draught occurred from the in fill walls at the balcony and cold floor was caused by the thermal bridges from the balconies.

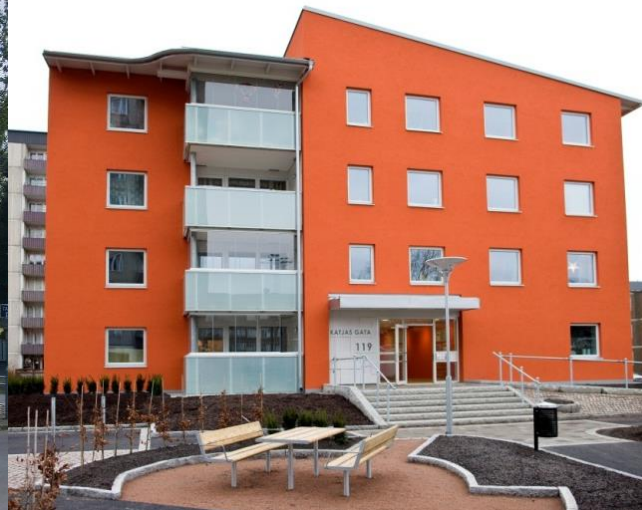
After renovation.

- Additional insulation, loft and crawl space
- Exterior additional insulation and sealing of the façades and new windows
- The joints between the apartments were rendered impermeable to air movement with floating putty on the floor
- New draught-proofed curtain wall on the balcony side
- New balconies on freestanding supports to minimise thermal bridges
- Individual metering of and invoicing for hot water

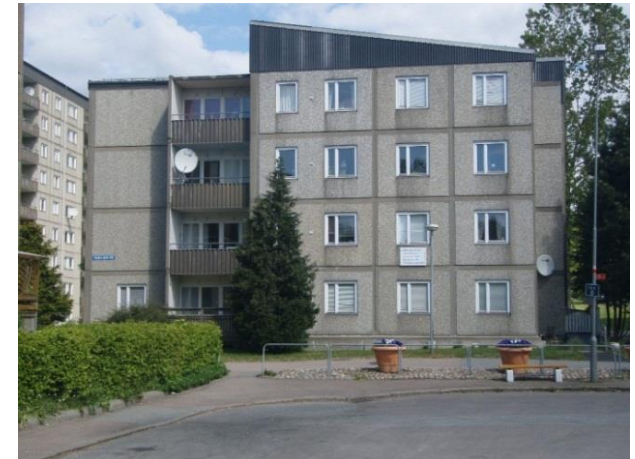
Before renovation

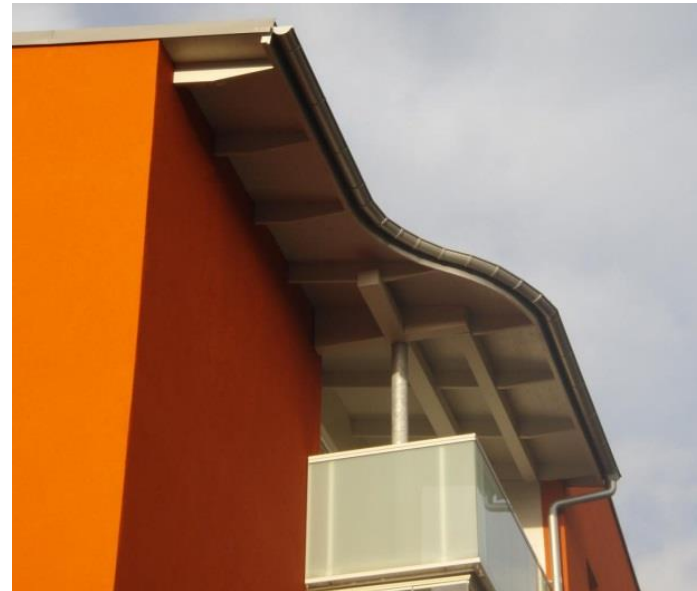
Extended eaves and balcony after renovation

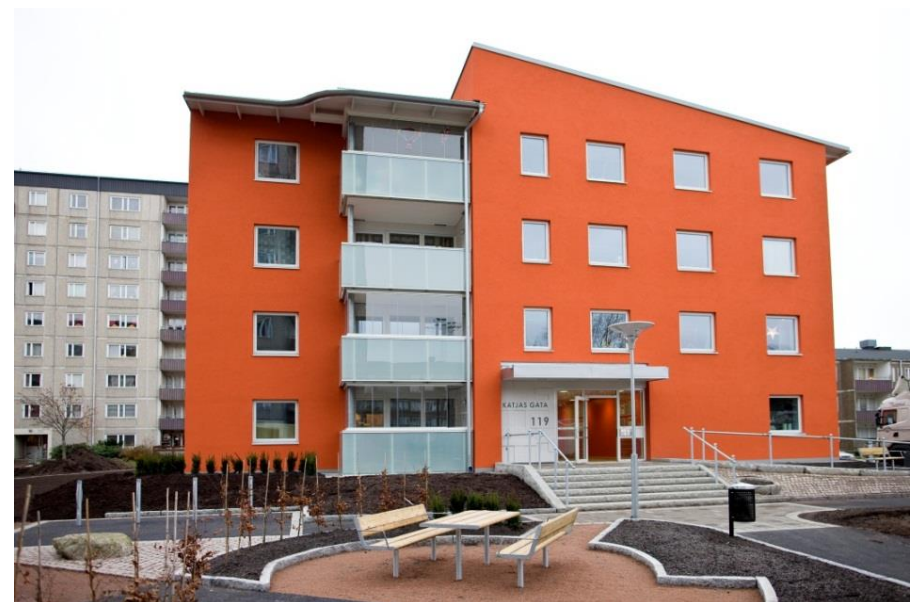
After renovation with new facade and balconies etc.
