6th International Building Physics Conference, IBPC 2015

## Energy consumption in an old residential building before and after deep energy renovation

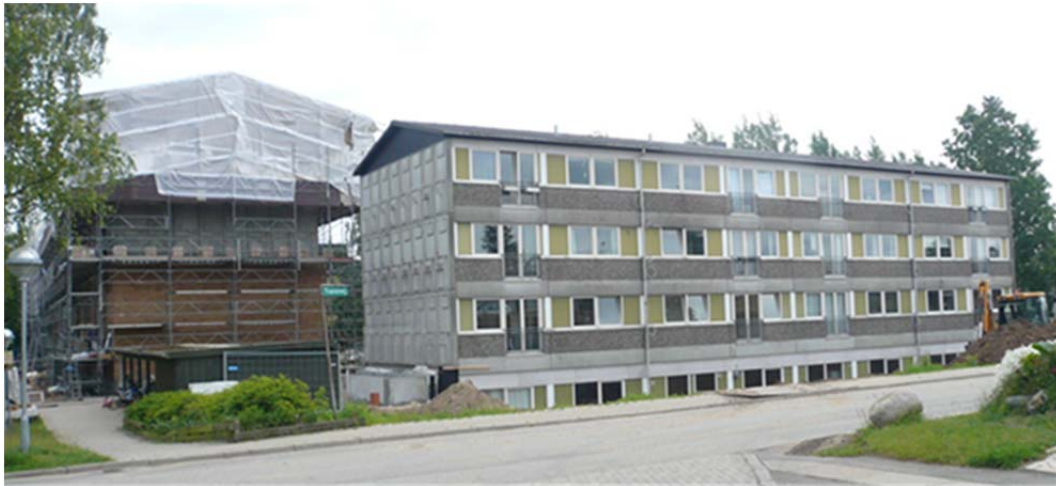
administrator is Boligselskabet Sjælland (Building Association Zealand). The buildings in general were in very poor condition and needed renovation - especially the concrete facades were worn down.

Fig. 1. Two of the three blocks at Traneparken. The photo shows the end wall of one block being renovated and the facade of the other which has not yet been renovated.

Traneparken has undergone a thermal rehabilitation process where 190 mm insulation material is added to the outside of the exterior walls. The original construction of the exterior wall was prefabricated concrete elements consisting of 100 mm concrete, 50 mm mineral wool insulation and 140 mm concrete. The concrete facades were worn down and had to be renovated. The 190 mm insulation was continued below ground level to reduce/remove any thermal bridges. Furthermore, the roofs and panel walls have also been insulated and windows have been replaced with triple-glazed energy efficient windows. In addition to the energy renovation of the facade, a new ventilation system and solar photo voltaic panels have been installed.

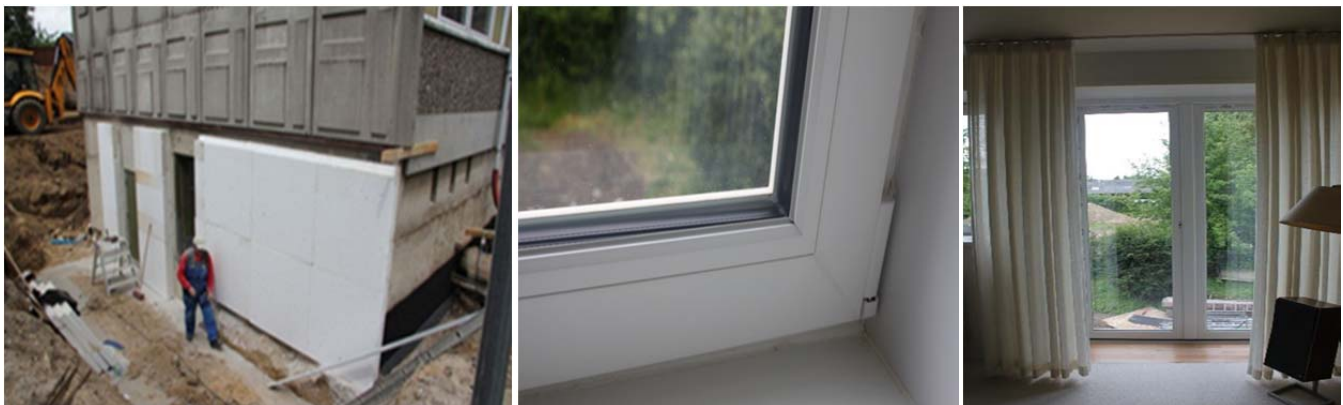
Fig. 2. (a) The external insulation (EPS) of the basement walls; (b) Lower corner of a plastic triple-glazed low energy window; (c) New balcony doors – plastic with energy-efficient glazing.

Traneparken has undergone a retrofitting process and the panel walls now consist of 285 mm insulation plus exterior solid standard bricks. The external insulation was continued under ground level to reduce/remove any thermal bridges. Furthermore, the roofs were also insulated and windows were replaced by triple-glazed low-E windows with low U-values.

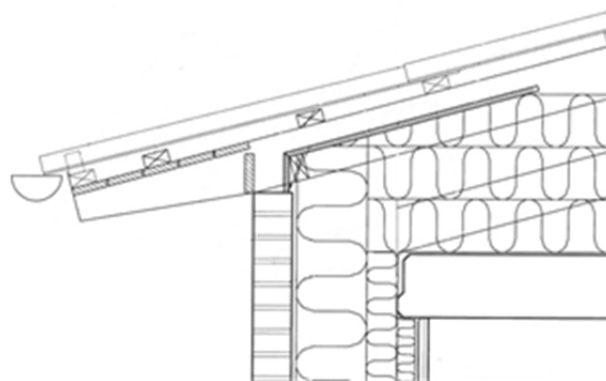
Fig. 3. The insulation in the wall was increased by 190 mm and the insulation in the roof by 250 mm. In the joint between external walls and the roof the insulation is continued in full thickness to minimize thermal bridges

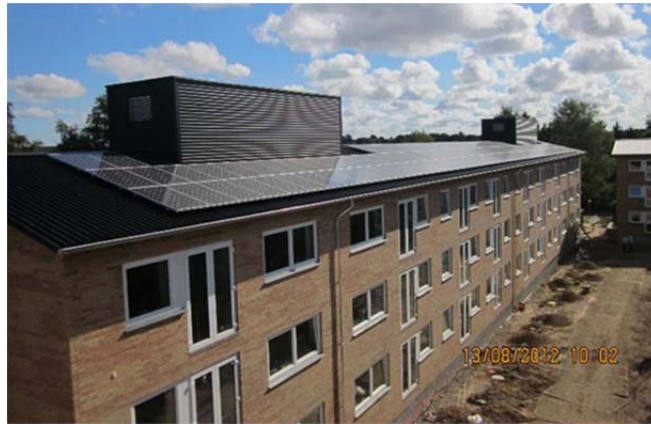
Fig. 4. The 33 kWp south-facing PV system and the coverings for the new mechanical ventilation systems located above each stairway.

Nothing was changed concerning the heating and lighting systems. After renovation, a balanced mechanical ventilation system with heat recovery was installed. The air was supplied to the living rooms and bedrooms and exhaust air from bathroom, toilets and kitchens. For the installation of the new demand-controlled balanced mechanical ventilation system with heat recovery, the existing exhaust air ducts were reused – thereby minimising costs and material use. Available space was identified and utilised for the supply air system. A PV system was installed on the roof to produce electricity.

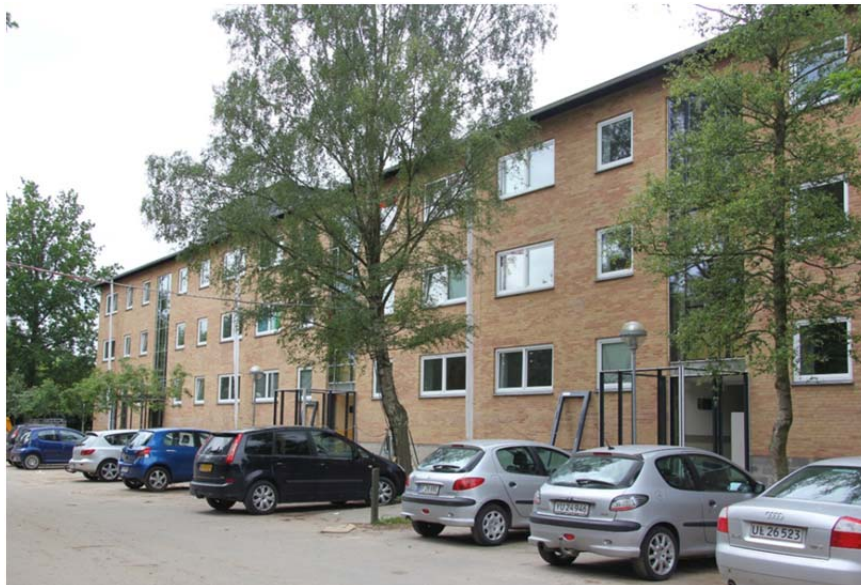
Fig. 5. Traneparken after renovation.
