6th International Building Physics Conference, IBPC 2015

## Retrofit of an historical building toward NZEB

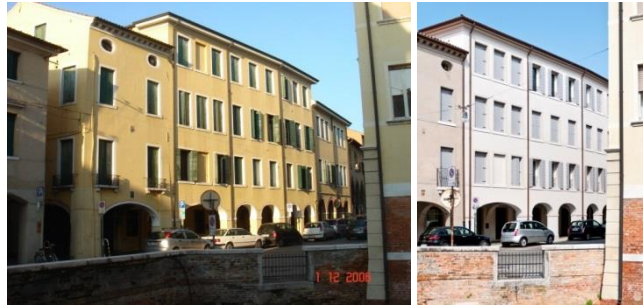
Fig. 1 General view of the building a) before and b) after the intervention.

CaøS. Orsola is located in the historic center of Treviso, in North East of Italy, very close to the city Cathedral. The building was the old seat of Polish Institute and now it is a listed building by Historical and Architectural Heritage Superintendence of Veneto Region. Originally it was a convent and it And it was inhabited for 40 years until 2000 and during the time it keep intact the original structure and architectural distribution. Then it was bought in 2007 for acting a deeply renovation and converting it in a prestigious residential building; The whole building (Fig. 1) is a gross volume of 6300 m<sup>3</sup> and it consists of an area of 4500 m<sup>2</sup>.

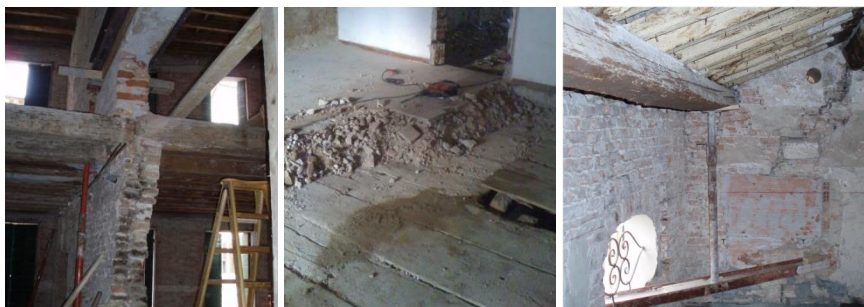
Fig. 2 Building envelope before renovation: a) crooked walls; b) demolished partition walls left and used as a substrate; c) beam support in the perimeter wall.

Building envelope before renovation presented a traditional construction system, based on bearing masonry with covered solid bricks. The floor had a wooden structure, while the ground floor leaned directly on soil. The roof is made of hollow tiles sheets with a wooden structure and a lightweight ceiling slab (Fig. 2).

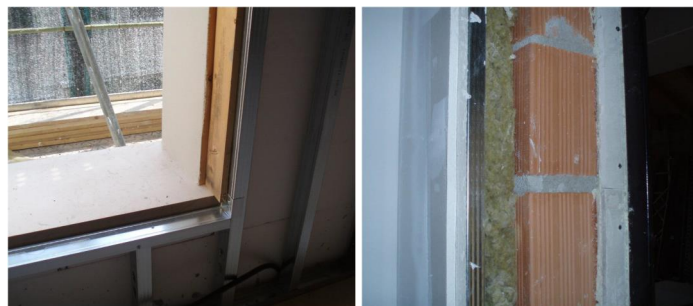
Fig. 3 Insulation on a) internal and b) external walls.

In the external walls the insulation is placed on the inner part (Fig. 3) and this solution meet the requirements of the Superintendence of Veneto Region, preserving the existing materials and the external architectural identity of the building. Specifically, two types of insulating are used: an expanded polystyrene (EPS) foam, placed directly on masonry, and a rigid mineral wool panel with a plasterboard cover. Roof was replaced with a new wooden structure and it was insulated with wood fiber and water tight covering. All existing windows are replaced with a low-energy double layer ones within wooden frames.

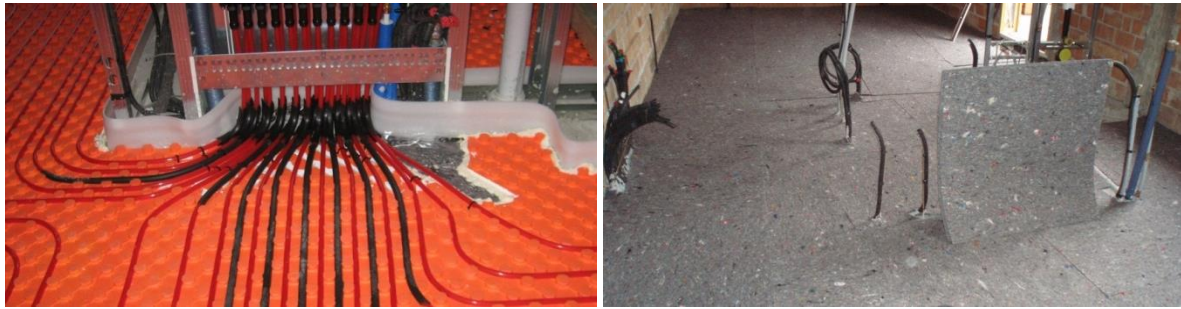
Fig. 4 Radiant system: a) collectors and b) TNT underflooring above system.

About technical systems, the HVAC generation system is a water to water centralized heat pump/chiller. The underlying well is the hot/cold water source and internal comfort is achieved exploiting a radiant system (Fig. 4) installed in the floor together with a dehumidification system for the summer period.

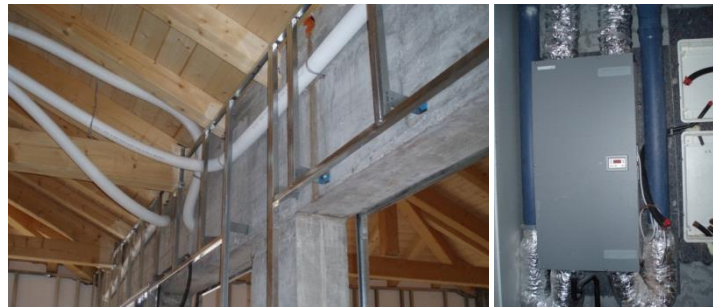
Fig. 5 Mechanical ventilation system.

For heating and cooling the system adopted is a 32 kW heat pump with a distribution by radiant floor system; another heat pump (20 kW) is installed for domestic hot water requirement (DHW); mechanical ventilation (Fig. 5) is provided by a system with heat recovery box (95% efficiency).
