Energy Procedia 00 (2015) 000-000

6th International Building Physics Conference, IBPC 2015

# Environmental aspects of renovations – case studies

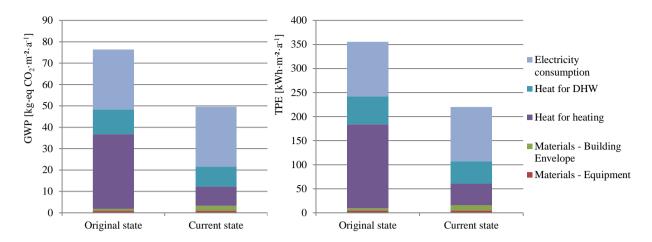
Fig. 3. GWP (left) and TPE (right) of Koniklecová 4 block-of-flats. Comparison of original and renovated building.

From both tables above we can see overall reduction of environmental impacts, caused by the renovations. As already mentioned before, this reduction is mostly caused by reduction of energy consumption. Charts with detailed results in GWP and TPE impact categories of Koniklecová 4 block-of-flats presented in Figure 3 confirm this. Both charts show that installation of new materials and equipment, their maintenance and repairs have minimum impact on overall results – in both categories only approx. 2 % in original state and approx. 7 % in current (renovated) state. This increase of materials' impacts is more than compensated by savings achieved during the use phase (heat consumption).
